ASSESSMENT REPORT

BAMBERG COUNTY COURTHOUSE

Bamberg, South Carolina

July 30, 2013

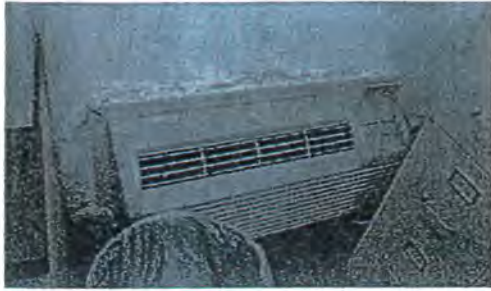
Thru-wall Mechanical unit

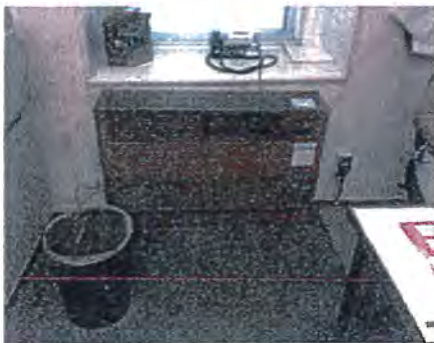
- The existing through wall packaged terminal heat pump is a de-centralized system which offers individual room control. The through wall concept provide ease of repair or replacement. Other systems capable of providing the same individual room control will be costly and require extensive modification to the electrical system. It is recommended the existing units remain in service. The through wall packaged terminal heat pumps appear to be varying in age as some units are recently replaced and some appear older. An audit to determine age and remaining life of each unit will determine replacement quantities.

Older Through Wall Unit

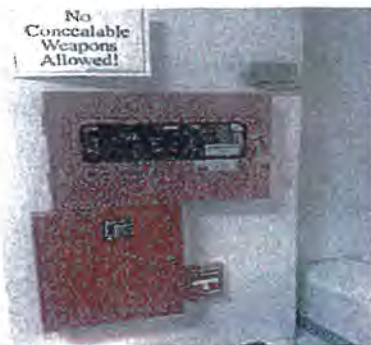
The existing fire alarm system is an old Simplex 2100 hard wired system that is not code-compliant and is outdated. The current system does not provide notification coverage as required by NFPA 72, the 2012 IFC, & ADA. The entire system should be replaced with a new fire alarm system.

Old Simplex 2001 Fire Alarm Cabinet

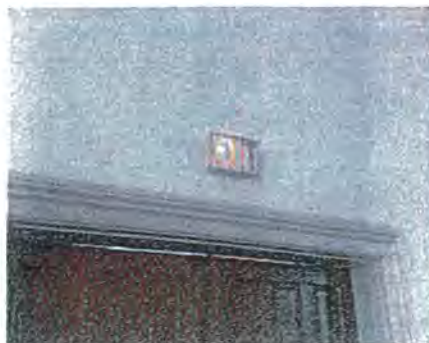
The existing exit lights are old incandescent lights. A large number of the exit lights had either one or both lamps out. New LED exit lights are recommended and will provide a short ROI due to energy and maintenance savings.

Incandescent Exit Light, One Lamp Out

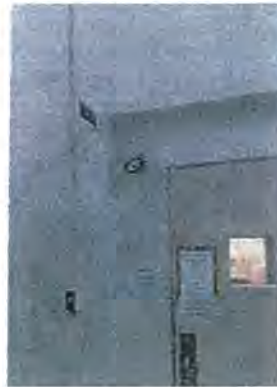
The existing emergency lights are remote heads that appear to be tied to an inverter or old DC system, but the source could not be located (probably somewhere in the crawl space). There were conflicting reports from staff as to whether or not the emergency lighting is working properly. New emergency lighting is recommended.

Remote Emergency Light

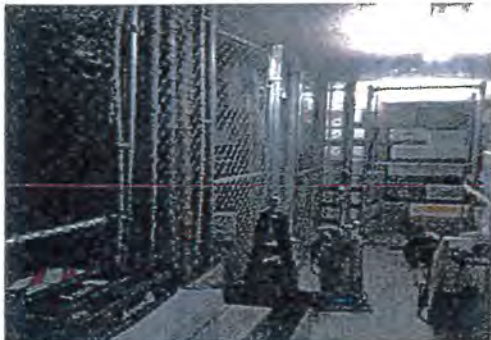
File storage on 1st floor is a fire hazard.

- A. Provide sprinkler coverage for the entire building in accordance with current NFPA 13 standards to protect all areas of construction. This will require a combination of two types of sprinkler systems. A dry-pipe system will be provided for the unheated attic and crawlspace areas and a wet-pipe system for all heated areas of the building. *(A current fire flow test will be required for the design of the building fire sprinkler systems.)*
- B. Provide a new fire hydrant at the sprinkler service tap location and locate fire department connection within one hundred feet of the hydrant to meet current NFPA 13 and 24 standards.

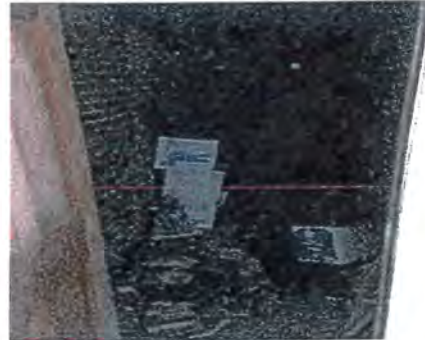
Combustible construction in crawlspace.

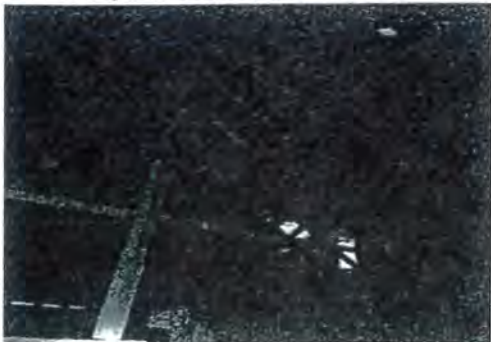
Combustible construction in attic areas

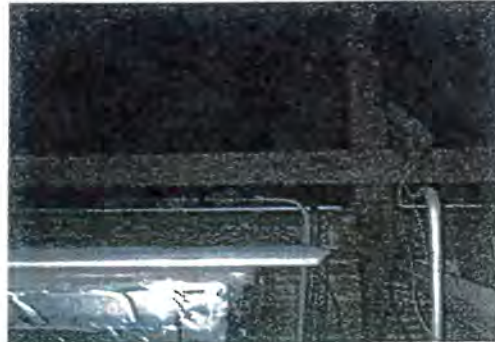
Combustible construction in attic areas.

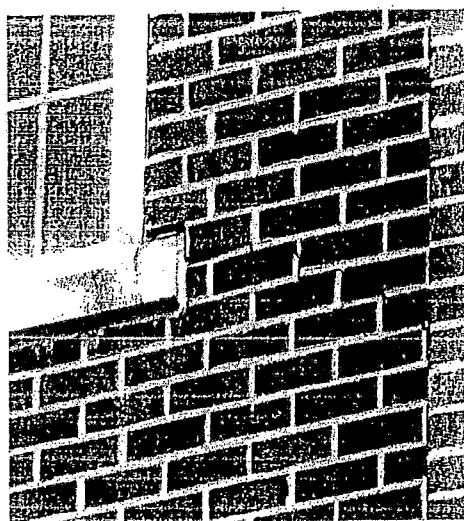
PHOTO P11

in two directions that the exterior window cracks noted above (See Photos P11 and P12.) showed.

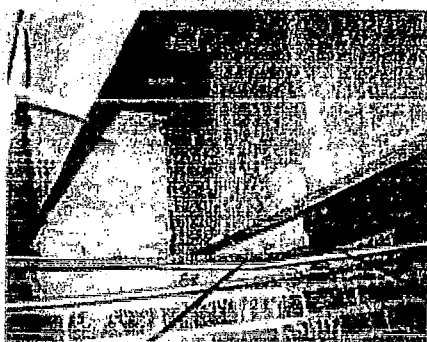
PHOTO P26

- a. In the original courthouse, most of the first floor construction consisted of wood joists and decking. The joists appeared to be 2 ½ x 14 members at about 18 inches on center spanning from wall to wall. The joists were set in pockets in the wall. All observed framing looked to be in good condition. (See Photo P26.)

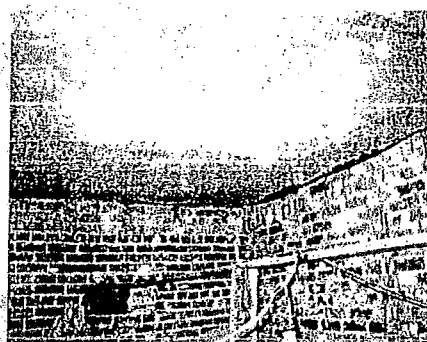
PHOTO P27

- c. In certain areas of the original building below vaults, concrete slabs appeared to have been added. (See Photo P27.)
 - d. In the area of the 1960 addition that has a crawl space, the framing consists of W14 steel beams at mid-span of the spaces with 2 x 12 joists at about 18 inches on center framing between the beams and the foundation walls. All observed framing and steel beams appeared to be in good condition. (See Photos P31 and P32.)

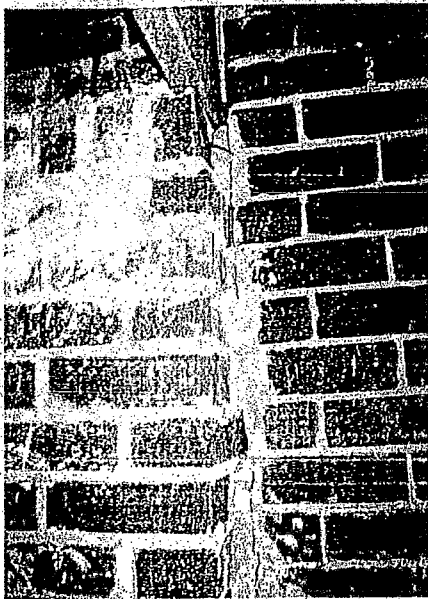
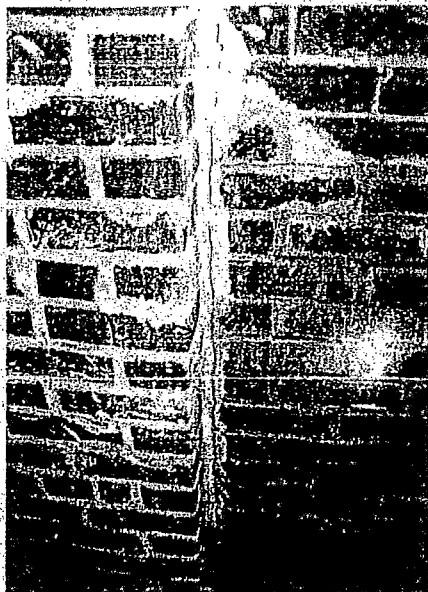
PHOTO P36 - P37

2. The joints between the original courthouse foundation wall and the 1960 addition foundation wall was observed to be separating and somewhat rotating (smaller at the bottom of the foundation wall and larger at the top of the foundation wall) at two locations located on sheet S3 in the appendix. These locations correspond to some of the more severe cracking observed in the upper floors. See Photos P33 to P35 for one location showing the crack as it goes up the wall and Photos P36 and P37 for the other location showing the crack as it goes up the wall.

The observed cracks at the foundation wall locations, at the walls at the upper floors, and at the exterior in a couple of locations all appeared to be due to settlement of the four corners of the 1960's addition away from the original courthouse building. It appeared that the right rear corner was experiencing the most settlement and cracking, followed by the right front corner. The left front and rear corners looked to be settling also, but possibly not to the extent of the other two corners.

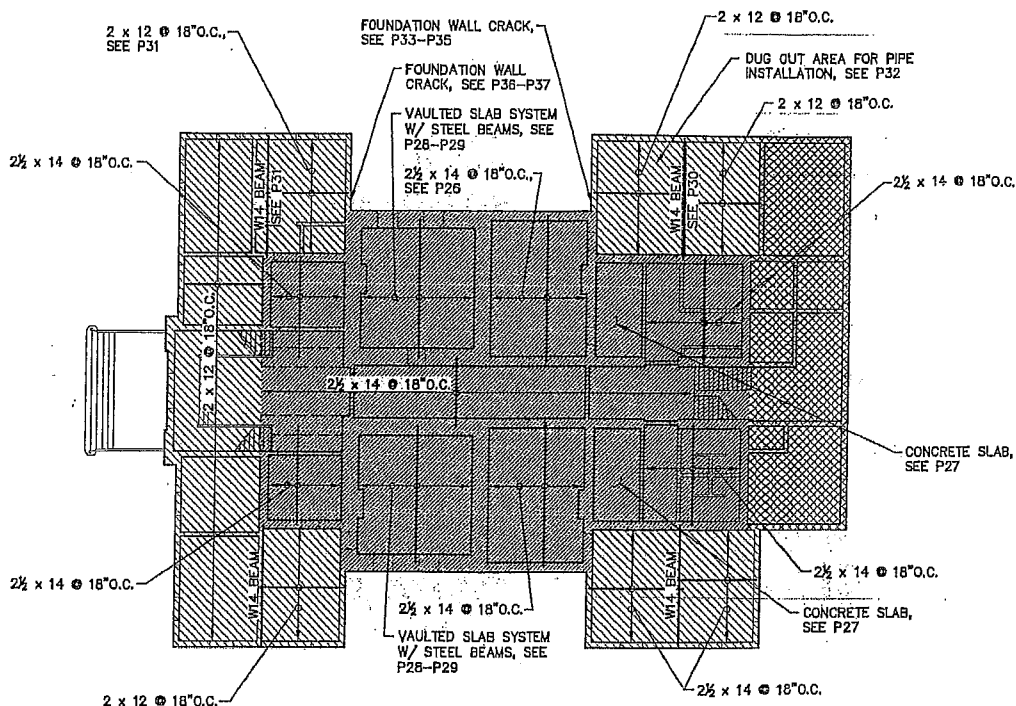
3. The observed first floor framing as seen from the crawl space varied from concrete floors to timber joists and decking. See drawing S3 in the appendix for framing layout and reference photos showing framing and general construction. None of the framing was observed to be physically attached to the walls.
