CONVERSION OF THE BAMBERG HOSPITAL TO :
BAMBERG ADMINISTRATIVE OFFICES
BAMBERG,
SOUTH CAROLINA

BAMBERG COUNTY COURTHOUSE
ASSESSMENT REPORT
Bamberg, South Carolina

BAMBERG COUNTY COURTHOUSE STRUCTURAL ASSESSMENT

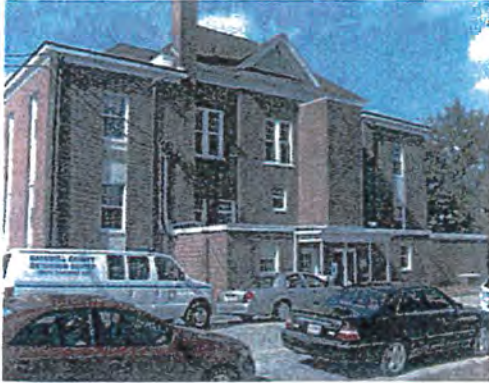
Rear Side

1. Building facades are brick masonry veneer with stucco accent panels between window units, wood trim around windows and at roof overhangs and soffits.

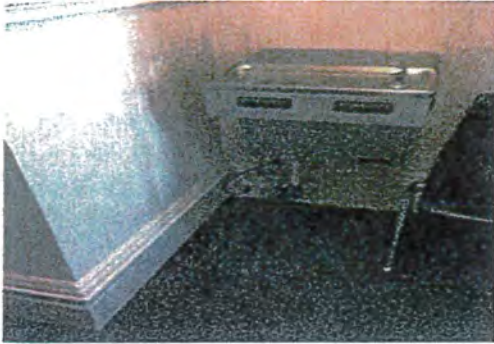
4. There is one electric water cooler located on each floor. Existing water coolers are ADA compliant. Fixtures appear to be in satisfactory condition.

Existing electric water cooler on 2nd floor

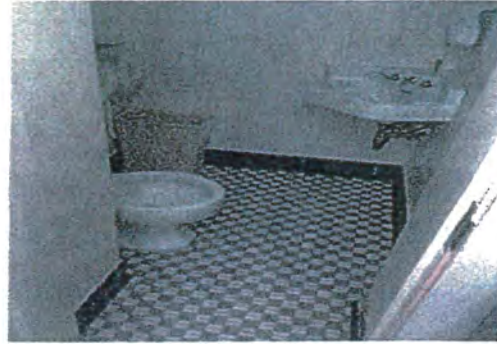
1. There are several locations of toilets on each floor of the courthouse. Toilet fixtures appear to be in reasonable condition and are functional however they do not meet current IPC (International Plumbing Code) requirements regarding fixture type and are non-compliant for ADA accessibility.

Existing individual toilet on 2nd floor.

1. Replace entire plumbing systems for the building.
2. Replace domestic water service line. This includes the water meter, tap and service line size to meet demands for new plumbing systems. Add backflow prevention device at new water meter and tap.
3. Provide domestic hot water for all plumbing fixtures. Domestic hot water heaters shall be tank type electric storage units furnished complete with digital controls,

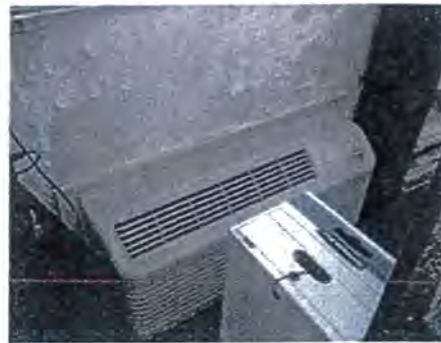
Newer Through Wall Unit

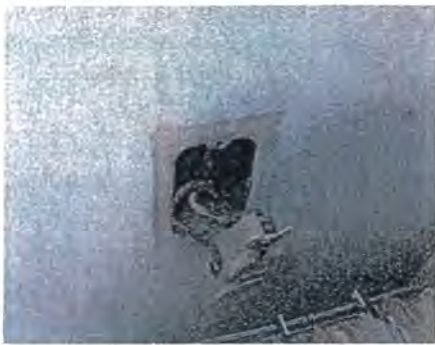
Many of the existing duplex receptacles in the original building appear to be 2 wire, 15A receptacles without a separate ground wire. These should be replaced with properly grounded receptacles and wiring. The newer duplex receptacles in the additions are 3 wire receptacles. The number and location of existing receptacles is inadequate for the needs of the client. Additional receptacles are recommended to reduce the use of power strips and extension cords. New HVAC Systems and new water heaters will require new power.

Receptacle without Ground Wire

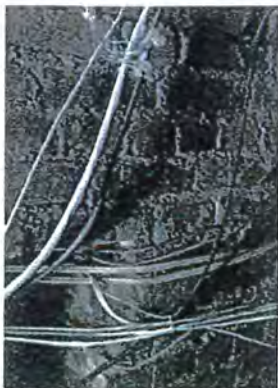
Existing wiring and/or conduit run in the Basement/Crawl Space consist of a mish-mash of EMT conduit, PVC conduit, Type MC Cable, Romex Cable, and Cat3/Cat5 cable. Much of the conduit and cable is improperly supported. A number of open junction boxes were observed in this space. Rewiring the building is recommended.

Romex and Other Cables
in Crawl Space

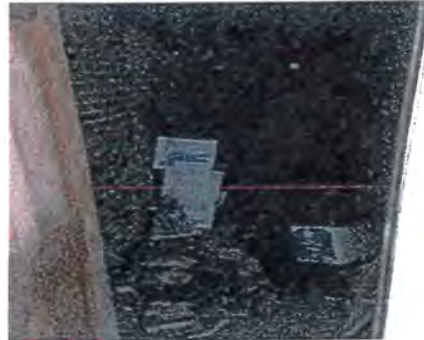
Combustible construction in crawlspace.

- A. Provide sprinkler coverage for the entire building in accordance with current NFPA 13 standards to protect all areas of construction. This will require a combination of two types of sprinkler systems. A dry-pipe system will be provided for the unheated attic and crawlspace areas and a wet-pipe system for all heated areas of the building. *(A current fire flow test will be required for the design of the building fire sprinkler systems.)*
- B. Provide a new fire hydrant at the sprinkler service tap location and locate fire department connection within one hundred feet of the hydrant to meet current NFPA 13 and 24 standards.

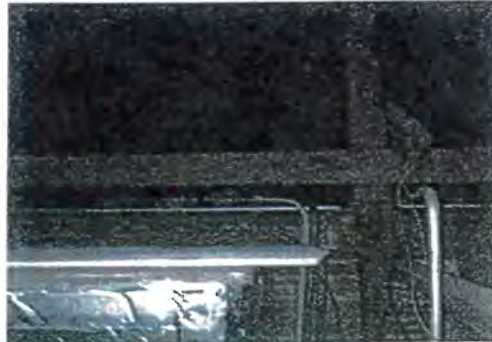
Combustible construction in attic areas.

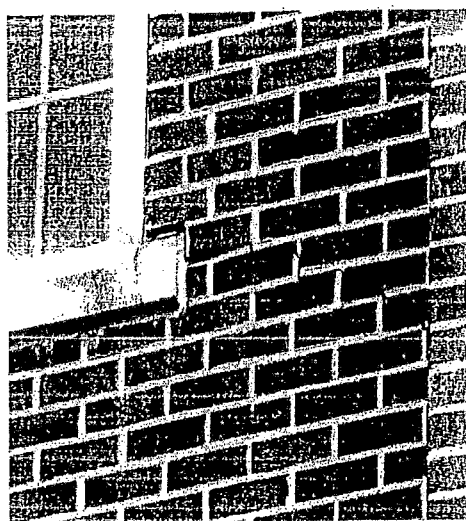
PHOTO P11

in two directions that the exterior window cracks noted above (See Photos P11 and P12.) showed.
