CONSERVATION OF CAROLINA BAYS IN GEORGIA

Purpose

The purpose of this project is to assess the distribution, status, and diversity of Carolina bays in Georgia and to promote their conservation through landowner collaboration, acquisition, easements, and educational outreach.

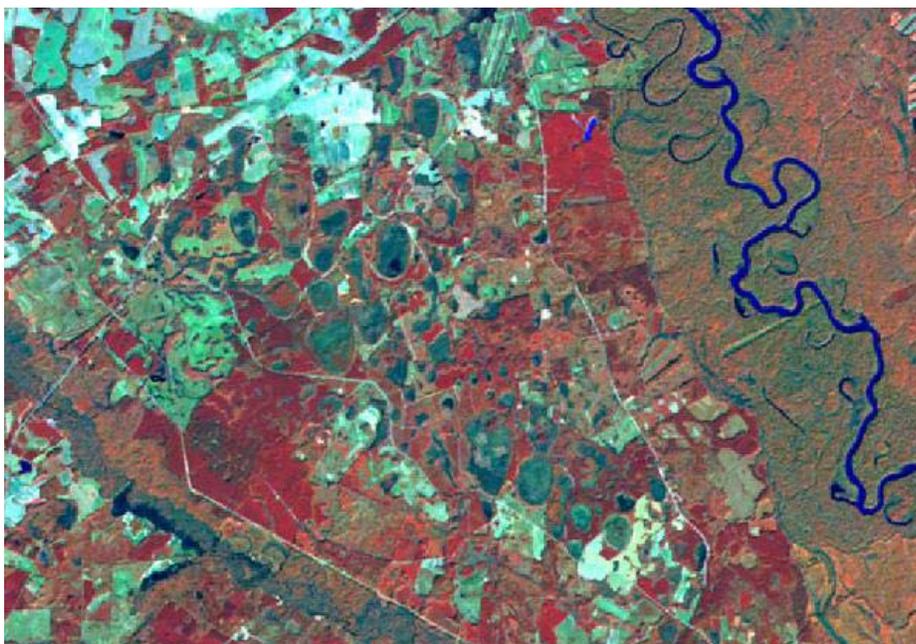
Figure 8. Example of satellite imagery used to define the macro study area. Note the Carolina bays in the center of the image. This image of Screven County shows the Savannah River to the east and Briar Creek to the Southwest.

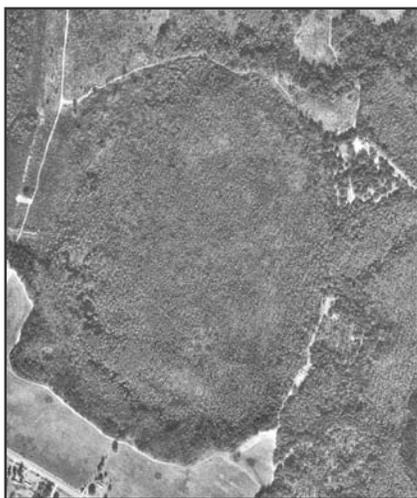
Figure 11. Integrity = 1 (Great)

Bays that appear able to support their ecological functions largely uninhibited are included in this ranking. This bay rated highly because it is large, with a majority of its margin is surrounded by relatively natural habitats. It also has no clear evidence of ditching, contains a variety of vegetation types, and shows little evidence of recent logging.

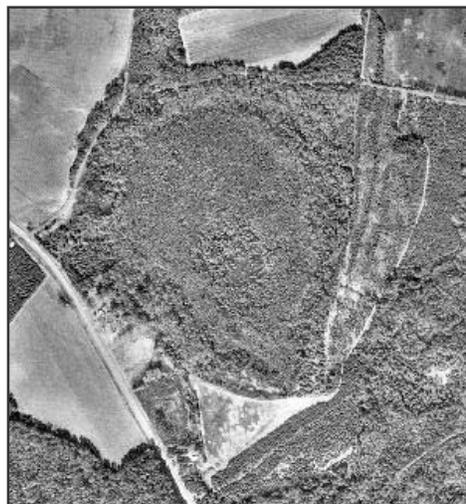
Figure 12. Integrity = 3 (Fair)

Bays that still perform their ecological services but have been impaired or limited in some manner are included in this ranking. Usually bays in this category are capable of being restored by simply allowing natural processes to play out. This bay rated more poorly because it is more isolated from connecting habitats, it appears to have a drainage ditch in the SW portion that appears to only be moderately effective, it is surrounded by roads, and its rim has been impacted by silvicultural activities.

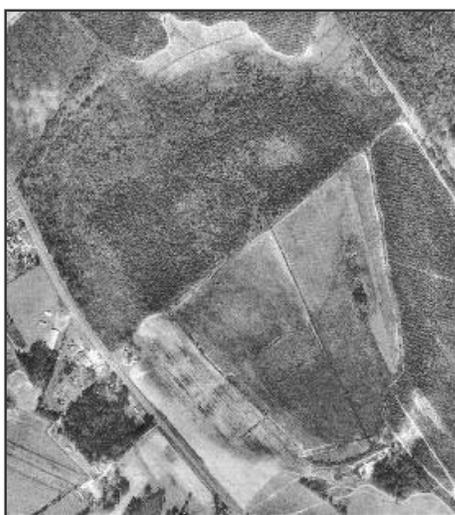
Figure 13. Integrity = 5 (Very Poor)

Bays in this category have been markedly disabled in their ability to provide important ecological services and are largely (but not entirely) degraded. Sites of this character can only be restored through an intensive and applied effort. This bay has been so ranked due to the intensity of ditching, removal of natural vegetation, relative isolation from surrounding habitats, proximity of large roads, intensity of impacts on the rim, and other factors.

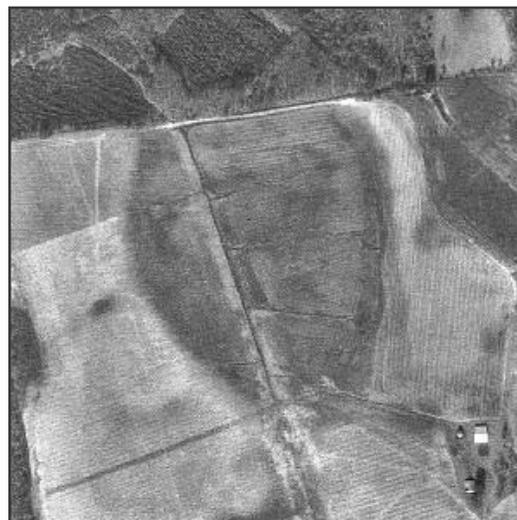
Figure 14. Integrity = 6 (Destroyed)

Bays that are no longer capable of supporting any of their ecological functions and no longer support natural vegetation are classified as "destroyed." The effort required to restore such a bay would likely be cost prohibitive, if possible at all. Often, these bays appear on aerial photographs only as dark "stains" on the soil. These dark stains show up well in cultivated lands.

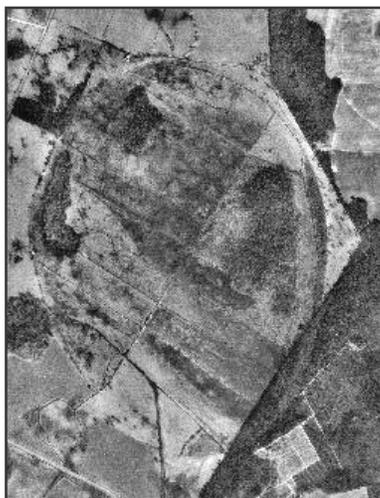
Figure 15. Ditching Intensity = 2 (Intense)
 Although the outline of this Jenkins County bay can be deciphered, it no longer supports a natural hydrologic regime and no longer supports classic vegetation patterns of bays. There are multiple drainage canals evident in the photograph. The ditches have successfully drained this wetland.

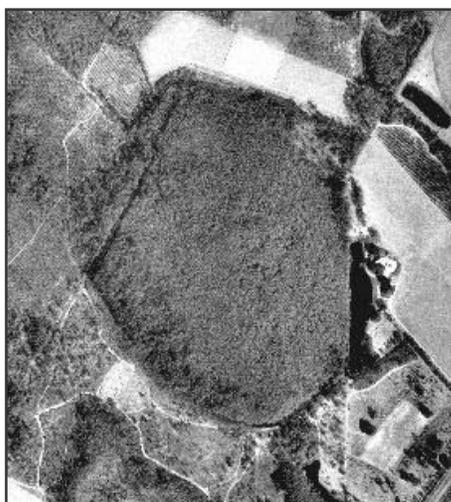
Figure 17. Buffer Condition= 0 (None)
 This bay has no natural buffer left. It is surrounded by pastures, pine plantations, and agricultural fields. With this lack of buffer, runoff and sedimentation could threaten the integrity of the bay. The numerous roads also found near the bay further fragment the landscape.

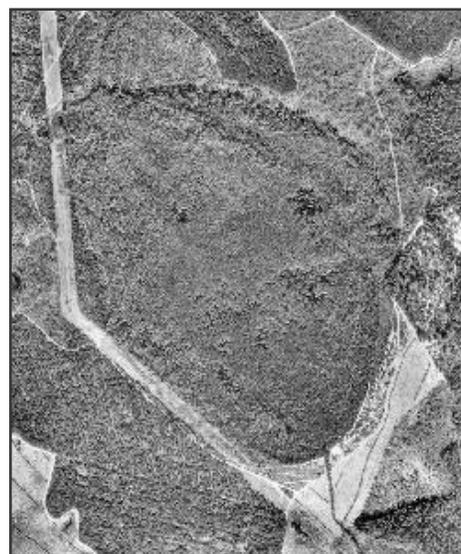
Figure 22. Hydrology = 1 (Isolated)

Despite the fact that a ditch can clearly be seen in the five o'clock position, the bay was likely isolated, in its natural state, from other major water systems and wetlands. Incidentally, based on a field observation, one author reports that this ditch probably does not function effectively because it has collapsed. One might not guess as much by simply reviewing this photography.

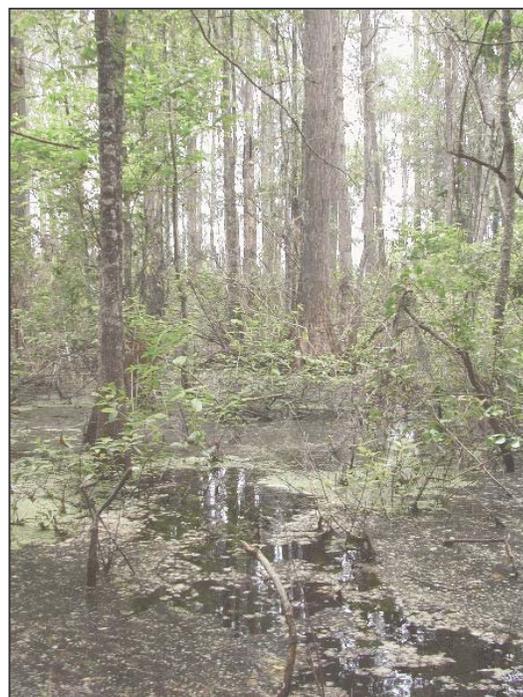
Pictured to the right is a bay in Cook County, one of dozens of bays that was visited. This particular site is owned by the County in conjunction with part of a land-application water treatment system. Although this bay continues to support important ecological functions for wildlife, there is evidence (not shown here) that portions of the bay may be impacted by nutrient inputs.
