State-Owned Facilities Update

PRESENTED BY THE SOUTH CAROLINA DEPARTMENT OF ADMINISTRATION JAN. 25, 2017

A Tale of Two Buildings

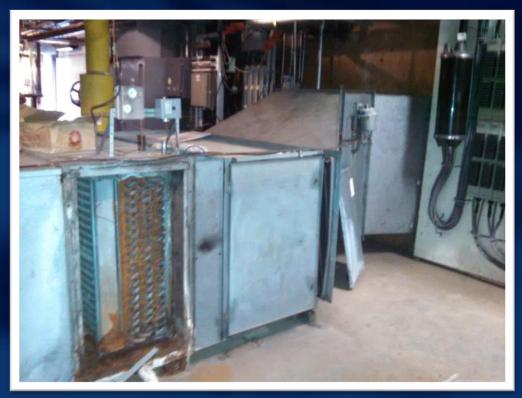
DHEC Sims/Aycock Building

Deferred maintenance - Items already passed the end of service life, but have not been replaced. **Recapitalization** - Replacement schedule for major pieces of equipment at the end of their service life.

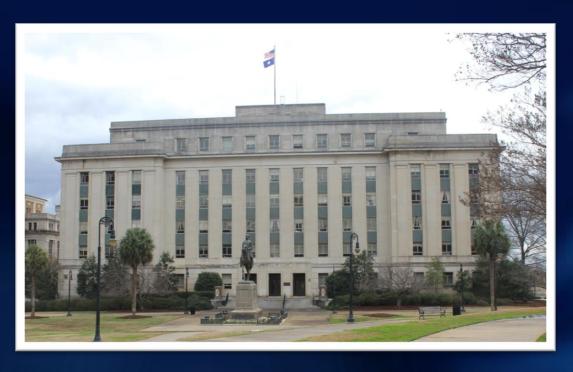
- Wade Hampton Building Built in 1938
 - ▶ Tenants: Admin, CG, Commission on Prosecution Coordination, SCDA, SFAA, Treasurer's Office
 - ▶ Deferred Maintenance Costs = \$ 5.3 M
 - ► Recapitalization Costs = \$ 18.8 M

- Columbia Mills Building Built in 1903
 - ► Tenants: DHEC, Confederate Relic Room, S.C. State Museum
 - ▶ Deferred Maintenance Costs = \$9.6 M
 - ► Recapitalization Costs = \$55.2 M

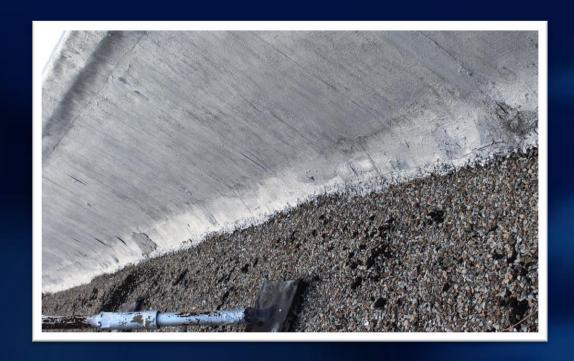
Wade Hampton Building

The roof's parapet contains numerous cracks, which allow water into the structure.

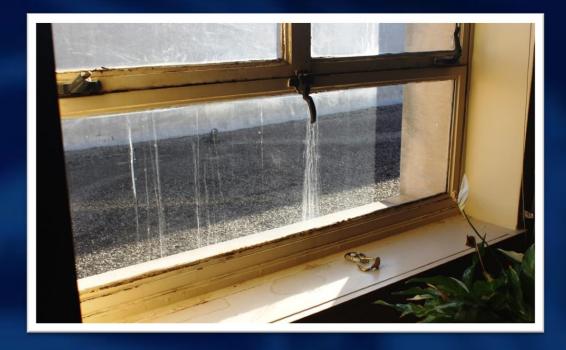
Original, single-paned windows are inoperable, rusted, and leak water and air.

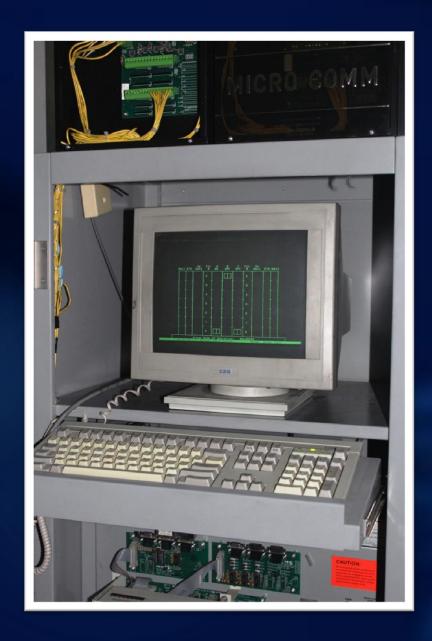
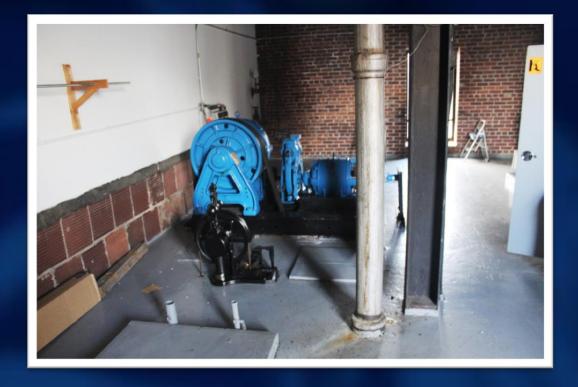
Wade Hampton Building

The building's outdated elevator system, including many of its original, 1938 mechanical operating parts and the computerized controls installed in the early 1990s, needs to be modernized.

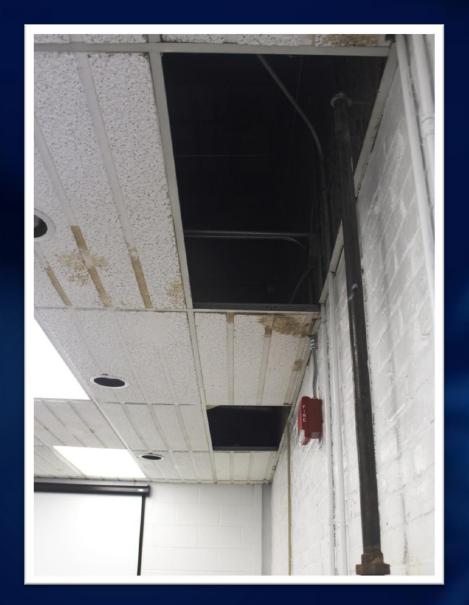
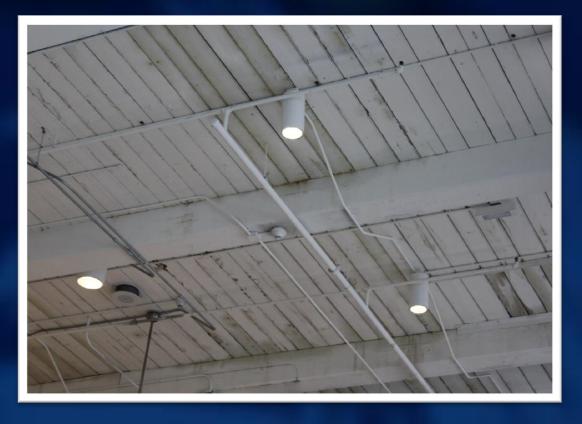
Columbia Mills Building

Water damage caused by multiple leaks in the current roof, which was installed in 1985.

- Recent project Made repairs to the fire suppression system -\$375,937.09
- This year, Admin requested \$5.8 million for:
 - ▶ \$2.1 million for the roof
 - ▶ \$2.86 million for windows
 - ▶ \$840,000 for atrium

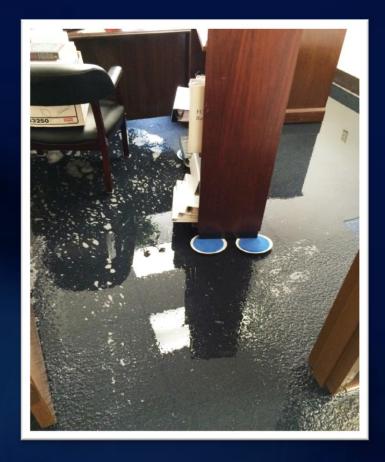
- Columbia Mills Building Roof Patching:
 - Crews installed the current roof during the building's 1985 renovation.
 - The roof warranty expired in 2001.
 - ► The roof is riddled with leaks, making it hard to prevent water infiltration and requiring patchings.

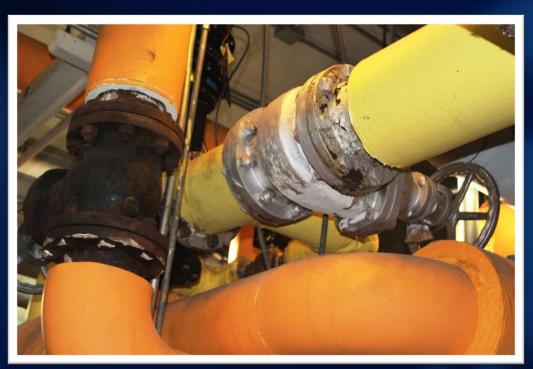
Wade Hampton Building

The Hot Water Distribution System needs to be replaced at an approximate cost of \$2.4 million.

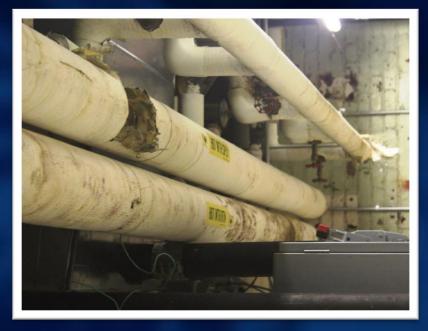
Columbia Mills Building

The HVAC mechanical system was installed in 1985. Replacing the system will cost \$23 million.
