ASSESSMENT REPORT

BAMBERG COUNTY COURTHOUSE

Bamberg, South Carolina

July 30, 2013

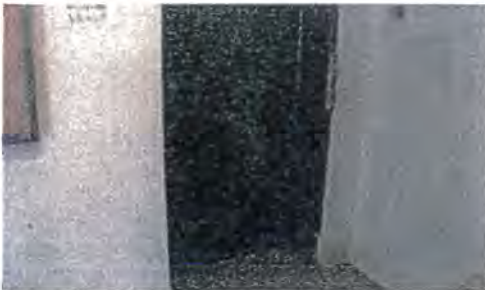
Rear elevator @ lower level

1. An elevator is accessible from the rear entrance/exit and provides access to all floor levels to the rear side of the building behind the main courtroom. Elevator access to the second level front spaces are only accessible through the second level main courtroom space.

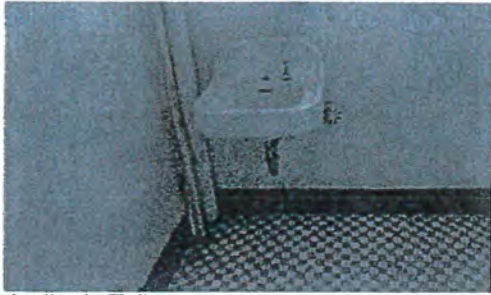
Auditor's Toilet

1. There are several locations of toilets on each floor of the courthouse. Toilet fixtures appear to be in reasonable condition and are functional however they do not meet current IPC (International Plumbing Code) requirements regarding fixture type and are non-compliant for ADA accessibility.

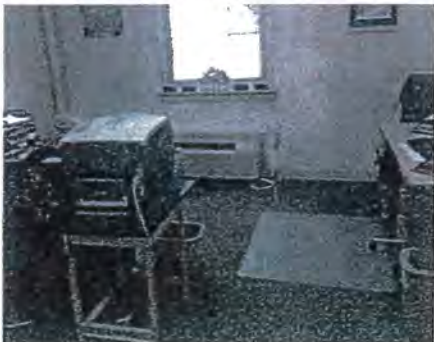
Newer Through Wall Unit

- The existing through wall packaged terminal heat pump is a de-centralized system which offers individual room control. The through wall concept provide ease of repair or replacement. Other systems capable of providing the same individual room control will be costly and require extensive modification to the electrical system. It is recommended the existing units remain in service. The through wall packaged terminal heat pumps appear to be varying in age as some units are recently replaced and some appear older. An audit to determine age and remaining life of each unit will determine replacement quantities.
