CONVERSION OF THE BAMBERG HOSPITAL TO :
BAMBERG ADMINISTRATIVE OFFICES
BAMBERG,
SOUTH CAROLINA

BAMBERG COUNTY COURTHOUSE
ASSESSMENT REPORT
Bamberg, South Carolina

BAMBERG COUNTY COURTHOUSE STRUCTURAL ASSESSMENT

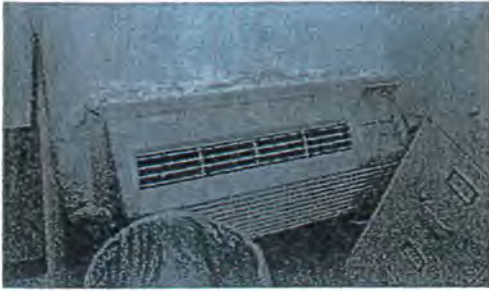
Thru-wall Mechanical unit

- The existing through wall packaged terminal heat pump is a de-centralized system which offers individual room control. The through wall concept provide ease of repair or replacement. Other systems capable of providing the same individual room control will be costly and require extensive modification to the electrical system. It is recommended the existing units remain in service. The through wall packaged terminal heat pumps appear to be varying in age as some units are recently replaced and some appear older. An audit to determine age and remaining life of each unit will determine replacement quantities.

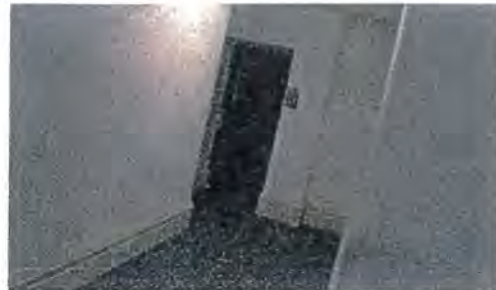
Rear elevator @ 2nd level

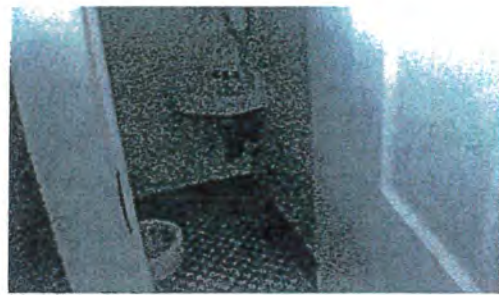
Holding Toilet

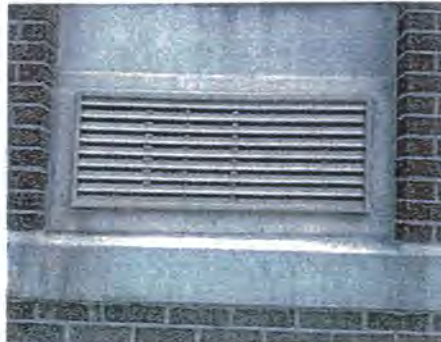
Exterior Through Wall Unit Louver

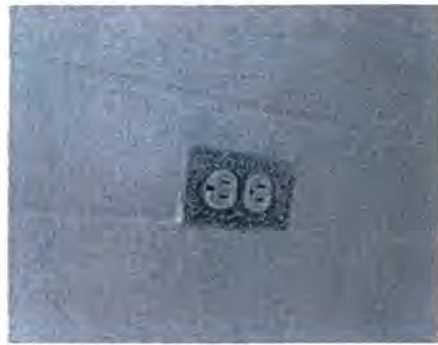
Receptacle in Addition

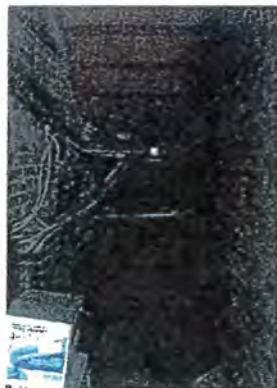
Existing wiring and/or conduit run in the Basement/Crawl Space consist of a mish-mash of EMT conduit, PVC conduit, Type MC Cable, Romex Cable, and Cat3/Cat5 cable. Much of the conduit and cable is improperly supported. A number of open junction boxes were observed in this space. Rewiring the building is recommended.

Romex and Other Cables
in Crawl Space

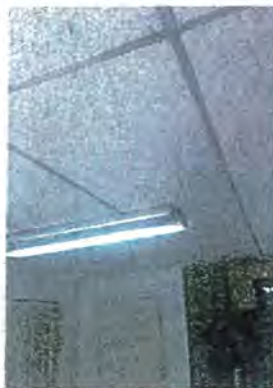
The existing lighting consists primarily of older T12 fluorescent fixtures, many in poor condition. New T8 fluorescent and/or LED lighting is recommended and will provide a short ROI due to energy savings. The existing lights are a mixture of recessed fluorescent and surface mounted fixtures. A mixture of different lamp colors was observed. Lamps should be one standard color throughout the building.

T12 Wraparound

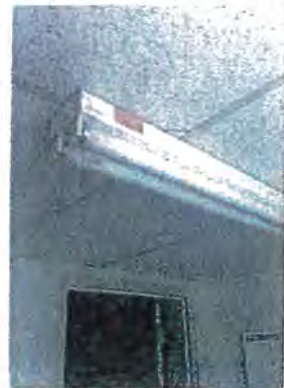
T12 Strip Light
